DELAWARE RIVER BASIN  
TRIBUTARY TO MAIDEN CREEK  
BERKS COUNTY  
PENNSYLVANIA  
NDS ID PA. 00721  
DER ID 6-460

# CHRISTMAN DAM

## PHASE I INSPECTION REPORT NATIONAL DAM INSPECTION PROGRAM

MARCH 1980

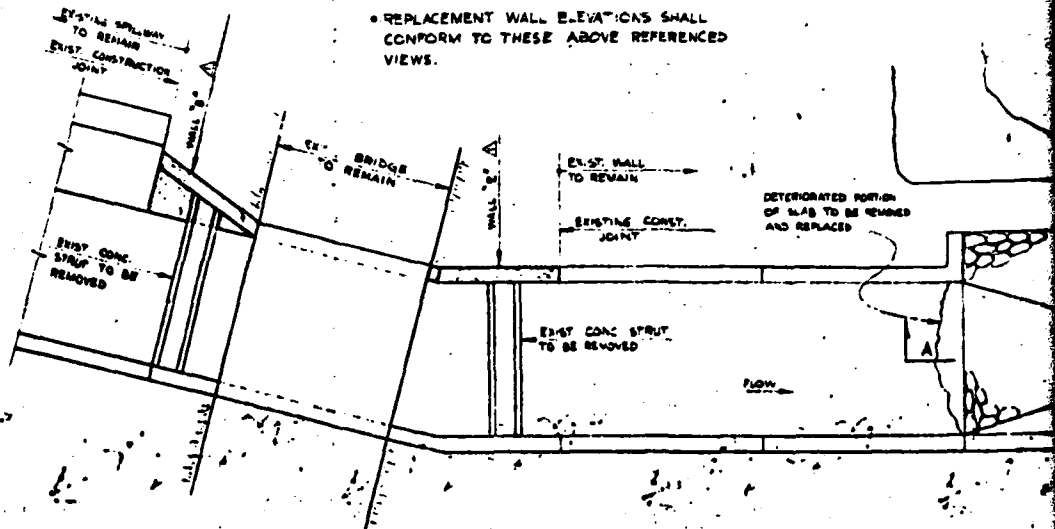
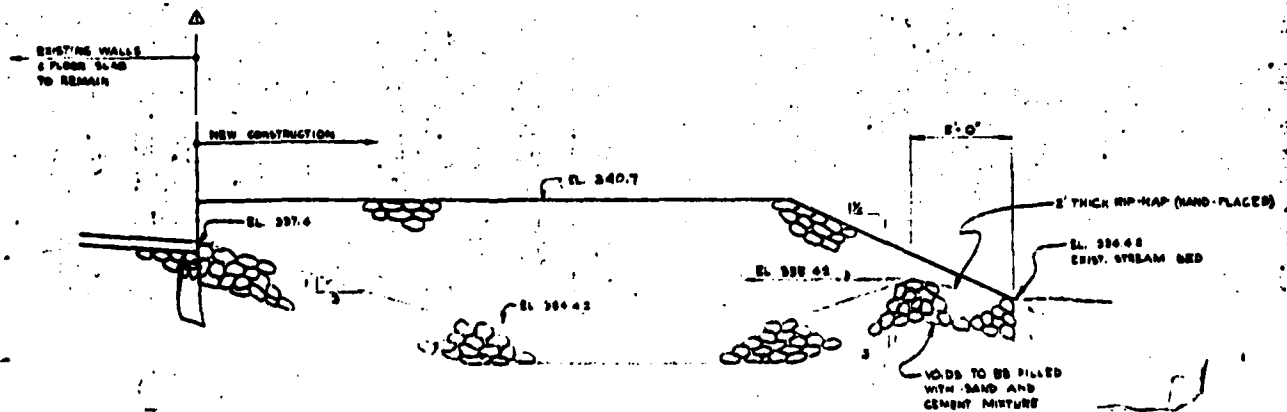
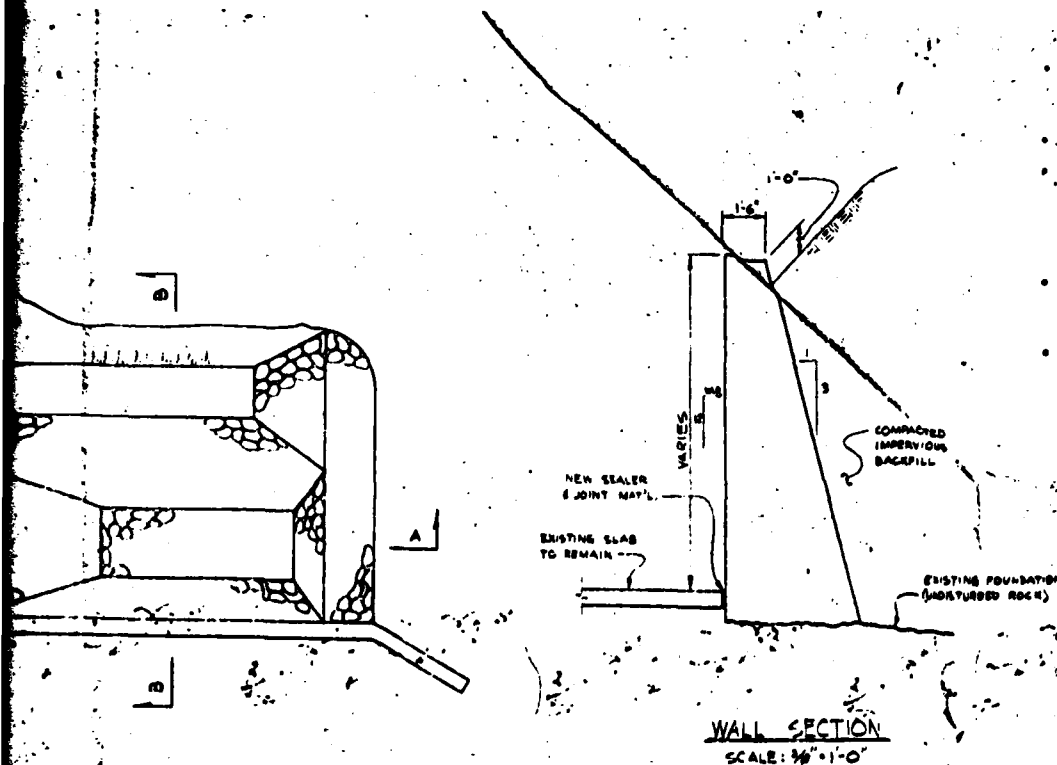
△ DENOTES PORTION OF EXISTING WALL TO BE REMOVED AND REPLACED (SEE WALL SECTION THIS SHEET, FOR REPLACEMENT WALL CONFIGURATION.) △

REMOVE DETEIORATED CONCRETE TO SOUND CONCRETE (SQUARE-CUT ENDS).  
REINFORCING SHALL BE CUT TO SOUND CONCRETE.  
DETROATED CONCRETE SHALL BE REPLACED IN PRESSURE MORTAR BUILD-UP.

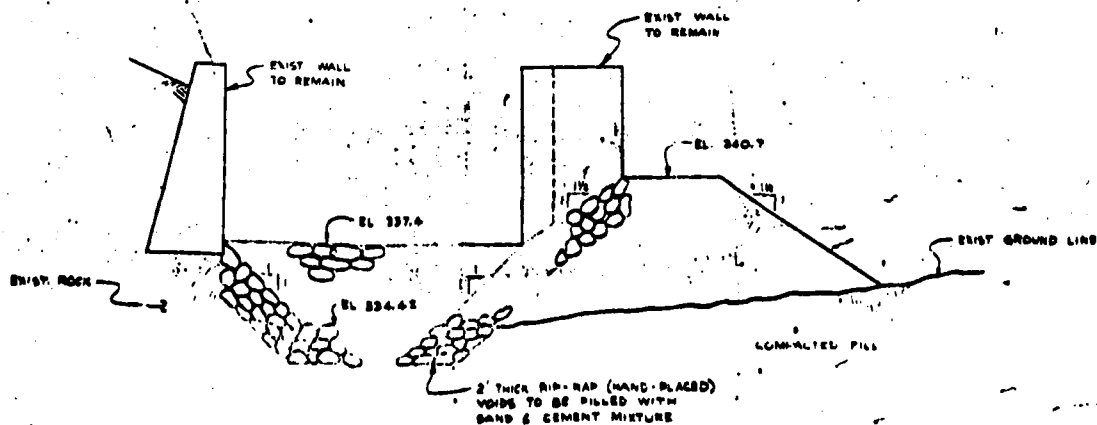
Sec. A-A

- ① Cut off wall with accept holes under and of plate
- ② Upper wire screen behind accept holes
- ③ This sheet is new. If there are any changes on other sheets they should be marked.
- ④ It would be better to have fill go to top of walls & properly sealed so surface run off would not be trapped behind the walls.
- ⑤ No detail of vert. joint
